Elevate Patio Door Field Service Guide

Removing Excessive Thumb Turn Play

ATTENTION: This Field Service Guide corrects the side to side / in and out play on thumb turn found in earlier versions of the Elevate Patio Door Handle.

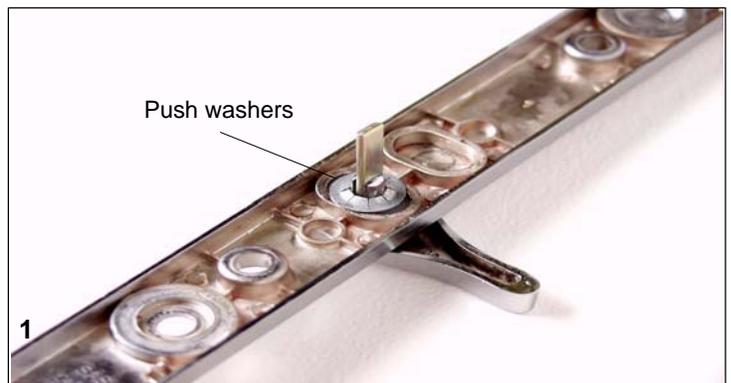
1. Remove the interior escutcheon plate from the panel by removing the two #8 x 2 1/2" Phillips panhead screws. Using a standard screwdriver or putty knife, pry the two (2) push washers that hold the tailpiece of the thumb turn to the escutcheon plate. You will need to carefully work around the washers to remove them. See figure 1.

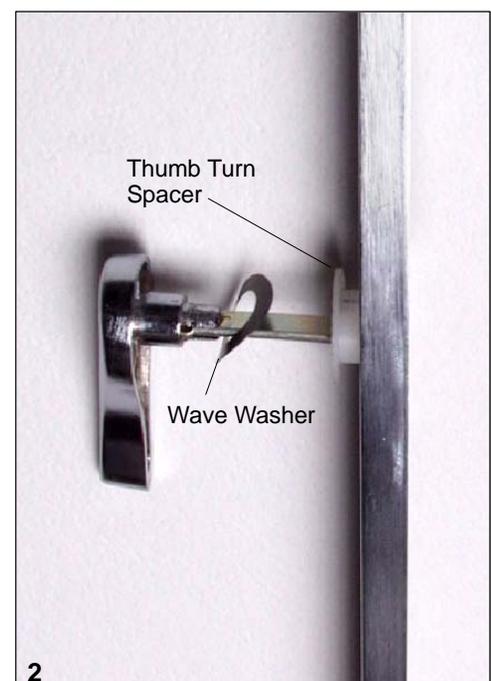
2. Remove the thumb turn from the escutcheon. Push the nylon thumb turn spacer into the oval turn lever hole on the handle side of the escutcheon. Slide the wave washer over the tailpiece. See figure 2.

3. Insert the thumb turn and tailpiece assembly through the thumb turn spacer and replace the push washer removed earlier with the new one provided. Replace the escutcheons and fasten with the panhead screws removed earlier.

CAUTION: Do not over-seat push washer as this may not allow proper thumb turn operation.
